Inspection Report

Triad's Best Home Inspection

Approximate Year Built	2005
Approximate Square Footage	3,378
Number of Bedroom	4
Number of Bath	3.1
Direction House Faces	SW

Inspection Date	4May2021
Inspection Time	8:00am
Weather Conditions	Recently Rained.
Outside Temperature	66°F
Price for Inspection

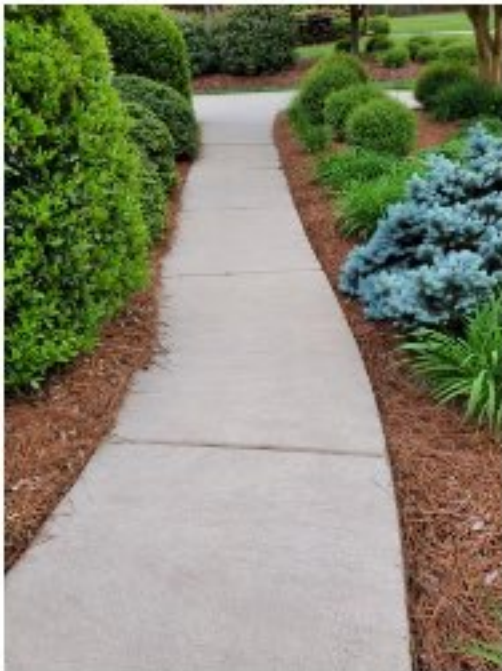
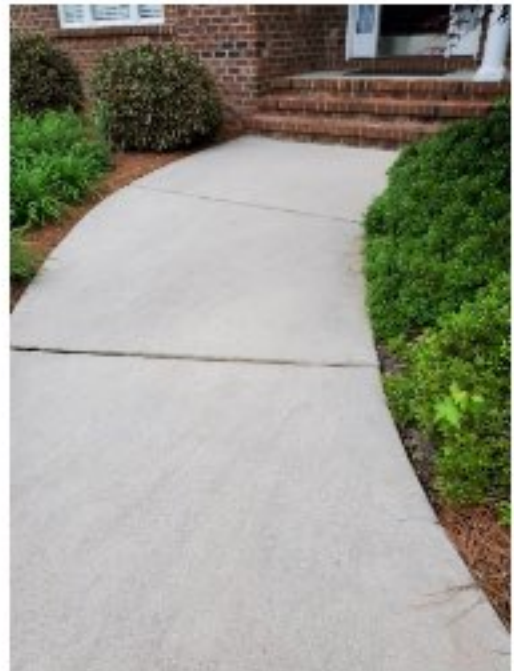
1.3) Sidewalk Conditions

The visible areas of the sidewalk appeared to be in serviceable condition at the time of the inspection.

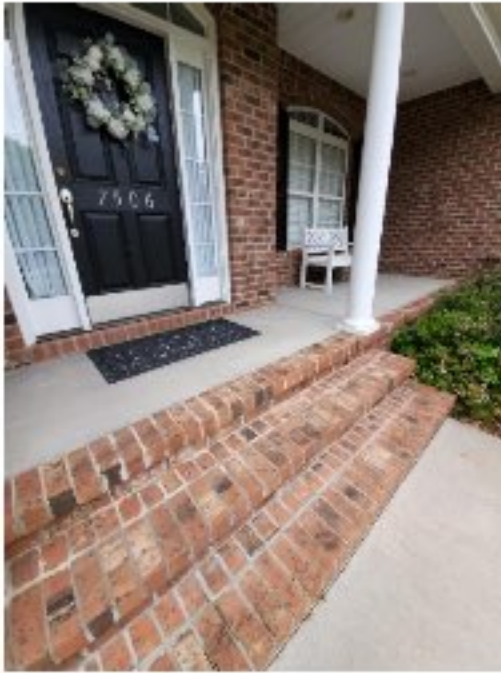
2.1) Front Entrance Conditions

The visible and accessible areas of the porch appeared to be in serviceable condition at the time of the inspection.

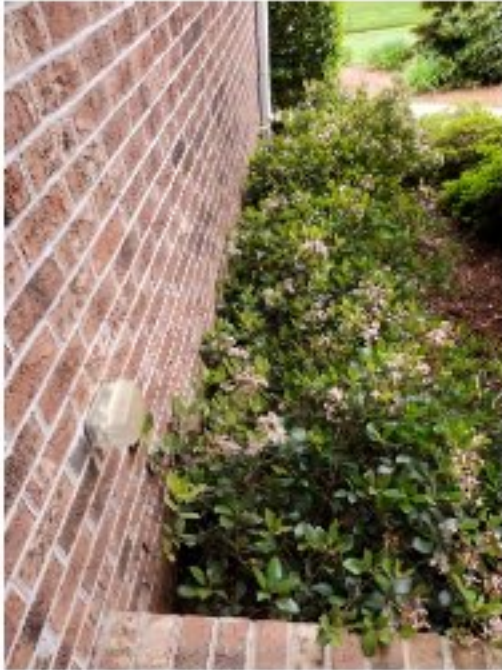
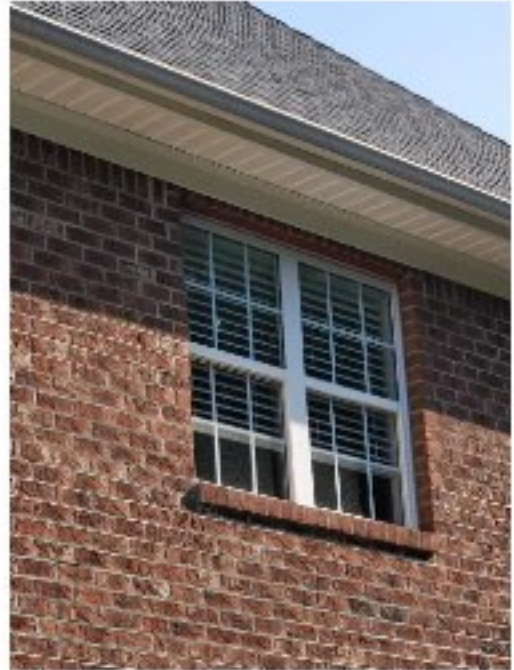
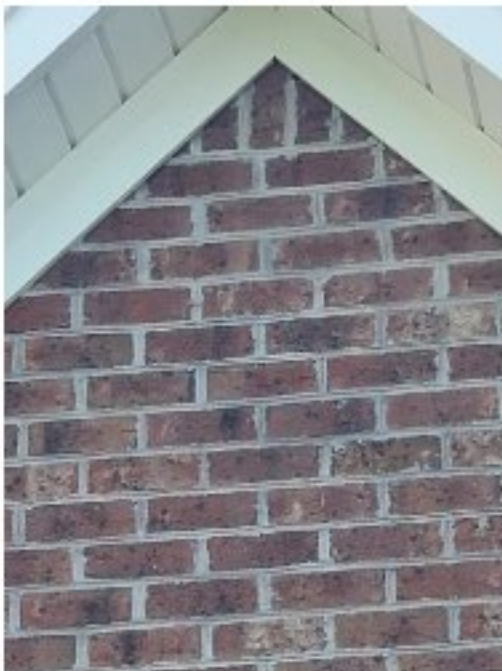
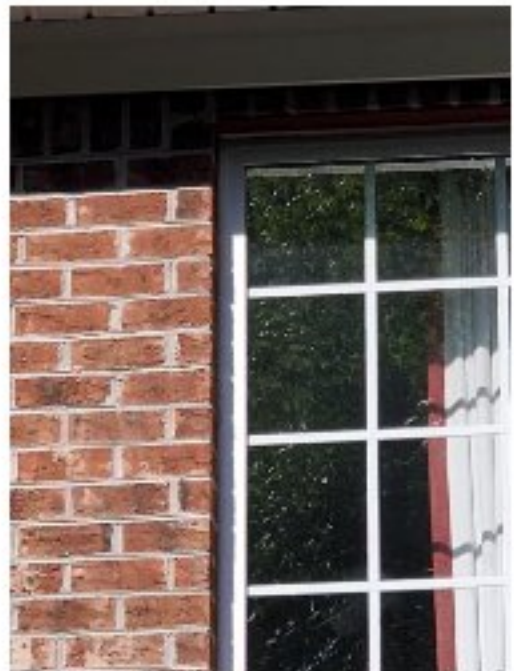
2.3) Exterior Wall Conditions

Mortar cracks at lintel. Recommend sealing.

Hole in mortar. This is an entrance for bees and other insects. Recommend sealing.

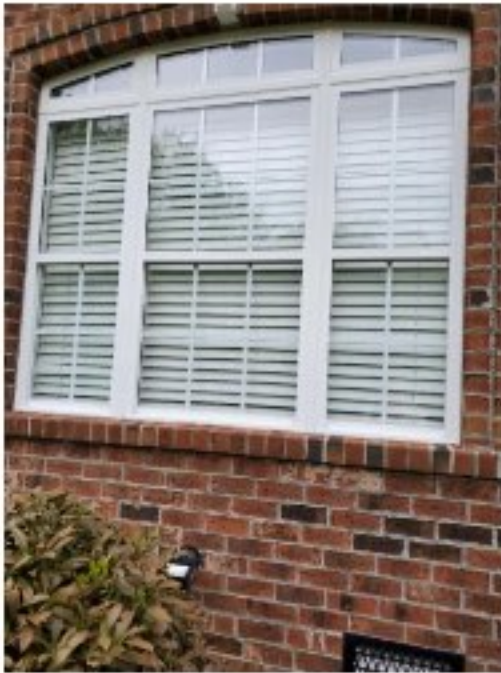
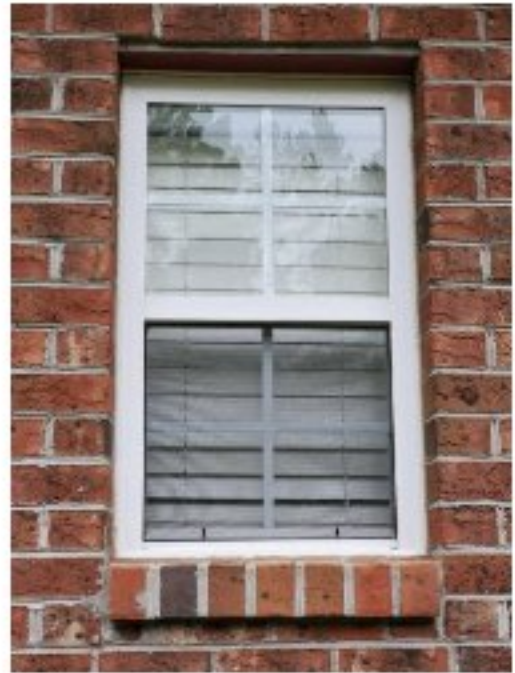
2.4) Window Conditions

Window sealant has become brittle and is separating in some areas. Appeared to be serviceable at the time of inspection. Recommend monitoring for further deterioration and/or water intrusion.

Kitchen sink window : bad seal. This can lead to energy loss at this window.

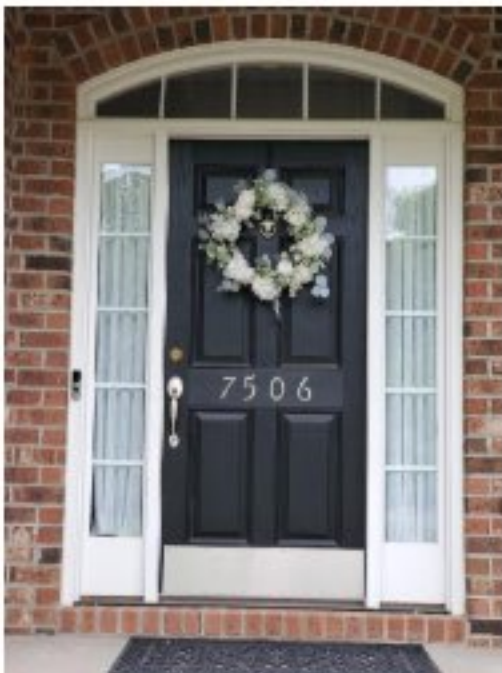
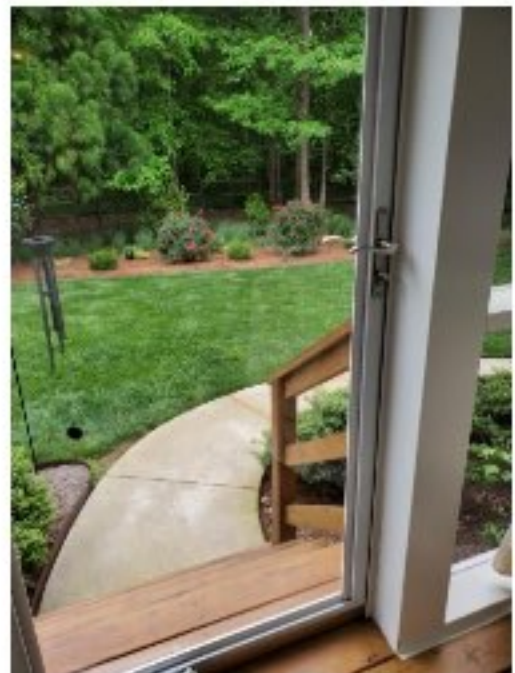
2.5) Exterior Door Conditions

Rear facing screened porch door difficult to latch.

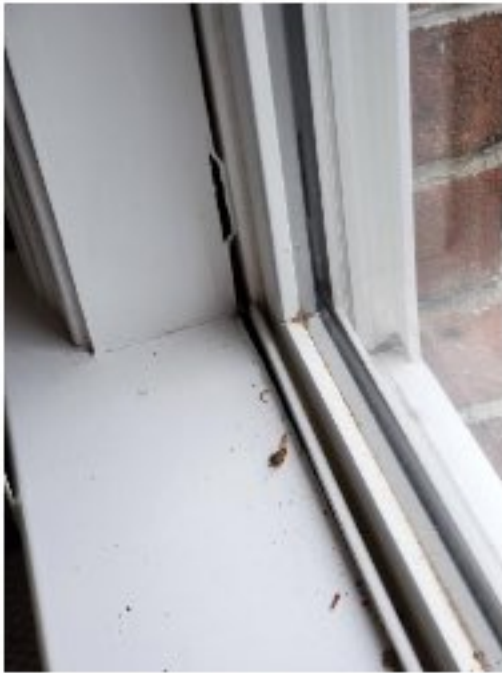
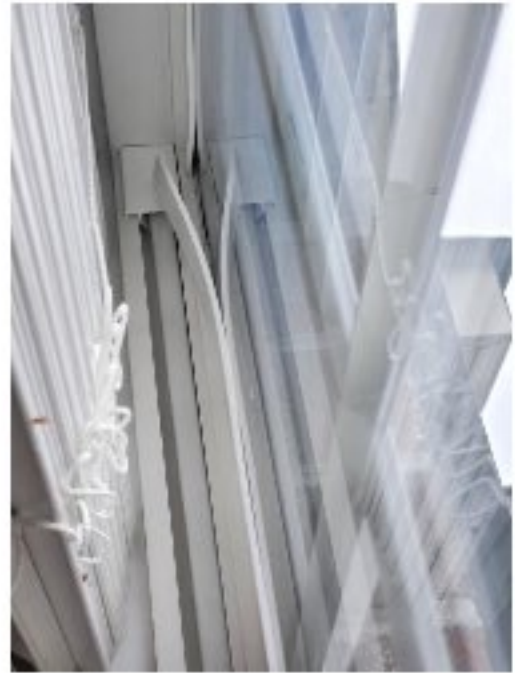
Window shows signs of separation. Recommend further evaluation by a licensed general contractor or window installer.

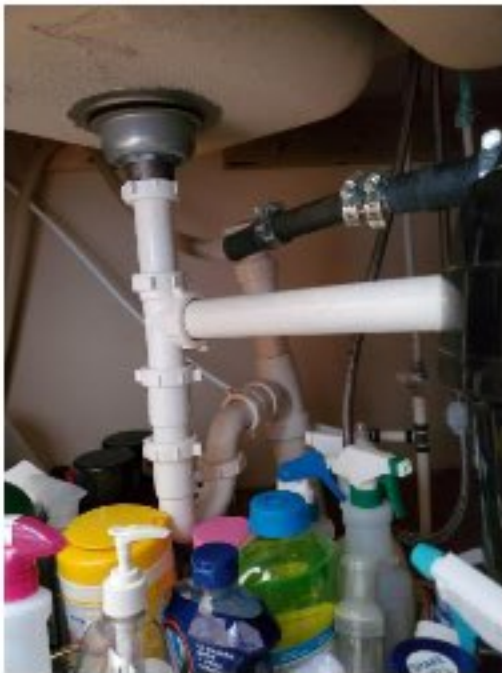
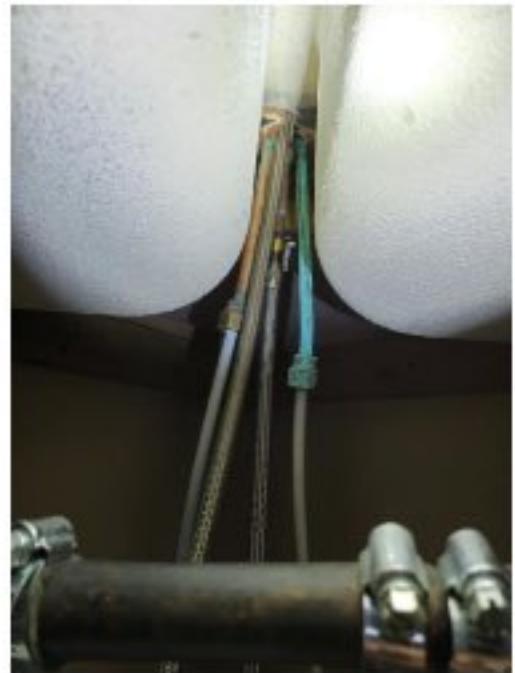
Faucet connections show signs of corrosion. Corrosion weakens the pipe and could cause leaky connections or pipe failure over time. Recommend monitoring or replacement by a licensed plumber.

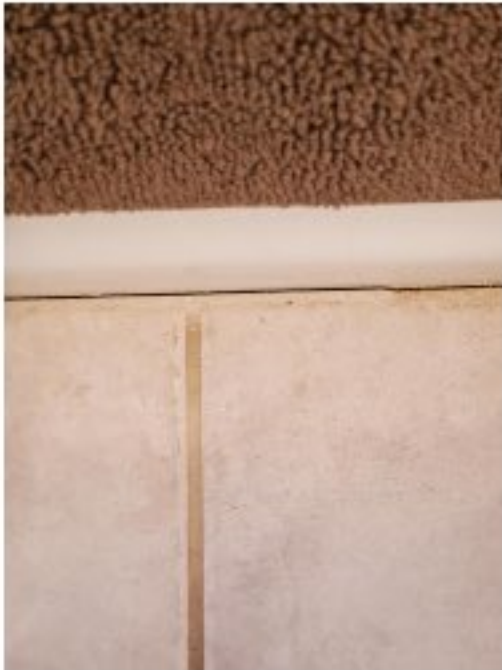
Appeared to be serviceable at the time of inspection. However, missing/cracked was noted in the floor grout at the tub. Recommend sealing to prevent water intrusion.

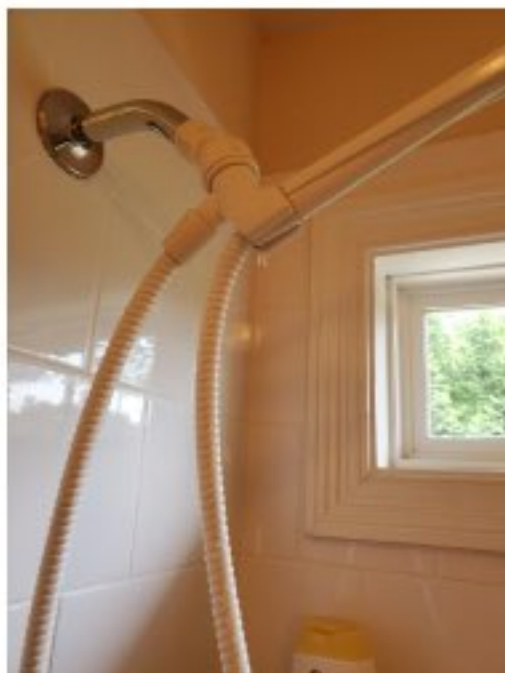
10.7) Fixtures

Shower head drips while shower is running. Recommend monitoring for further deterioration.

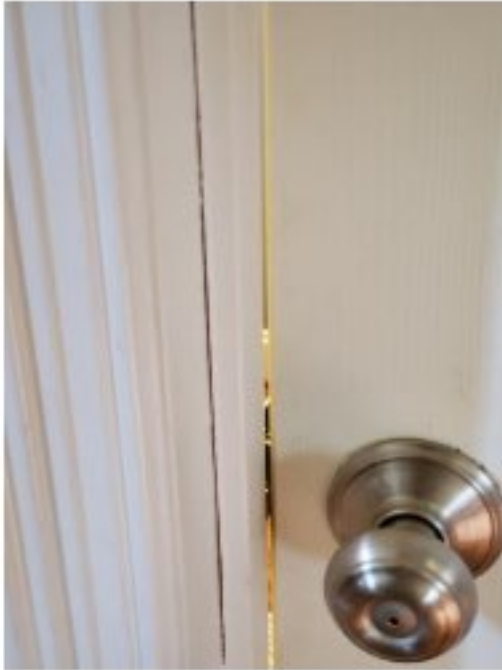
Door has light showing when closed. This could be bad installation or signs of settlement. Recommend monitoring for further movement.

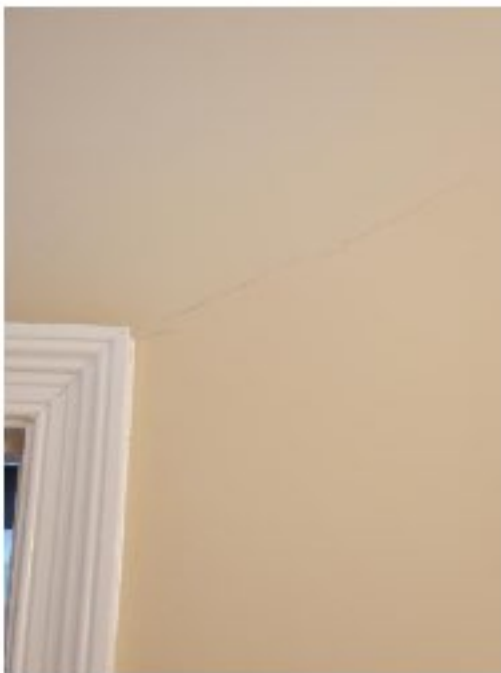
Minor cracking at upper right corner of bathroom entry door. Door rubs slightly at top right. Possible evidence of some settlement of the foundation or piers. Recommend monitoring for further movement.

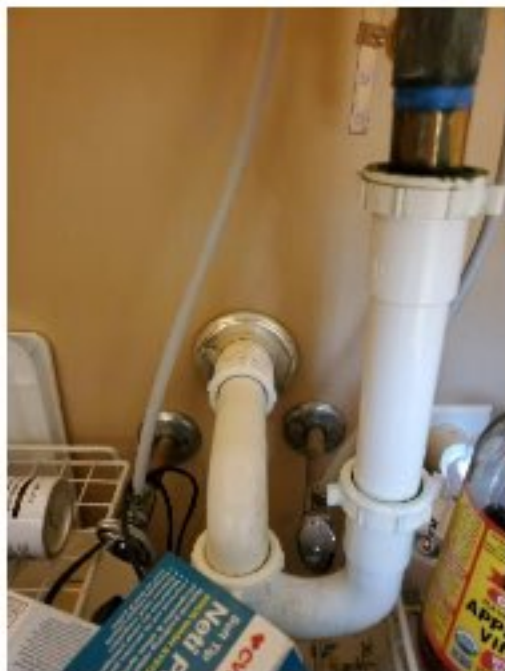
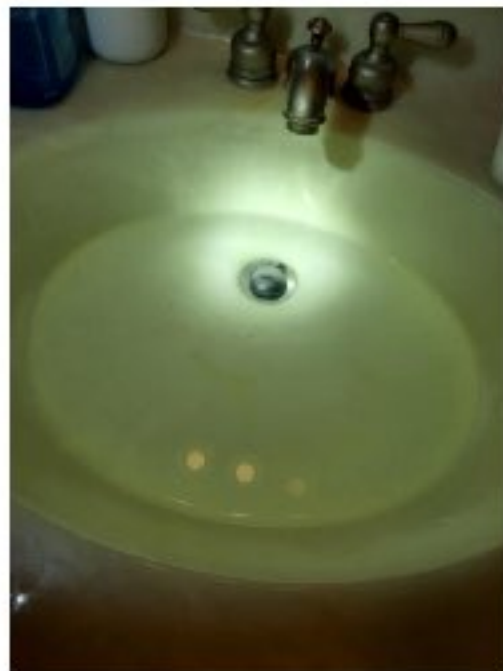
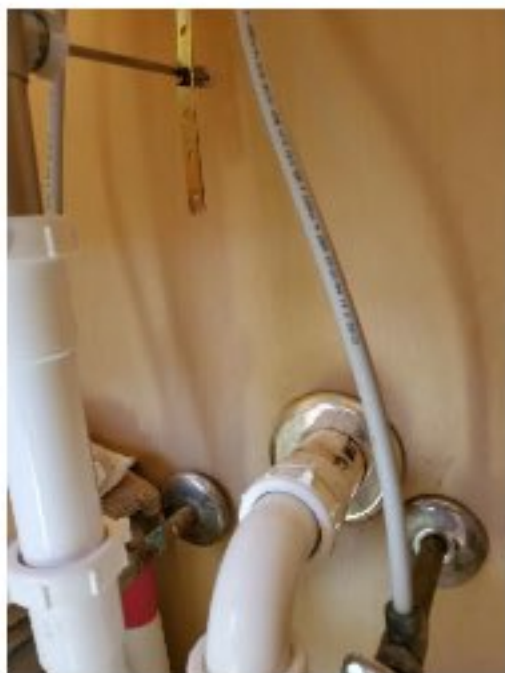
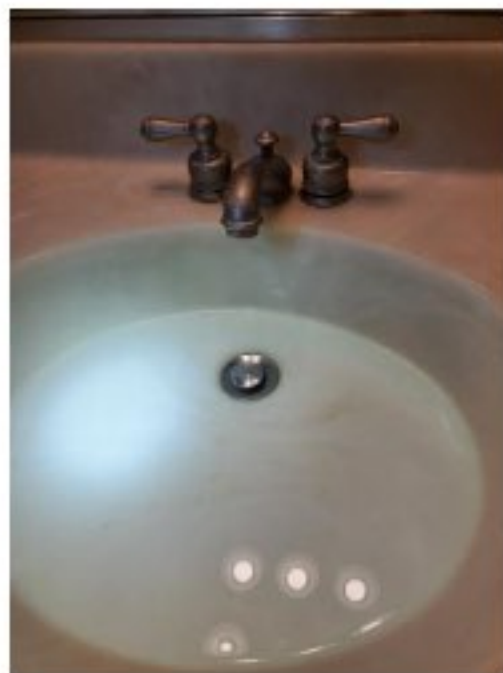
Both sinks drain slowly. Running water may fill the sink faster than it can drain. This could lead to flooding the sink and water damage to the surrounding areas. Recommend correction by a licensed plumber.

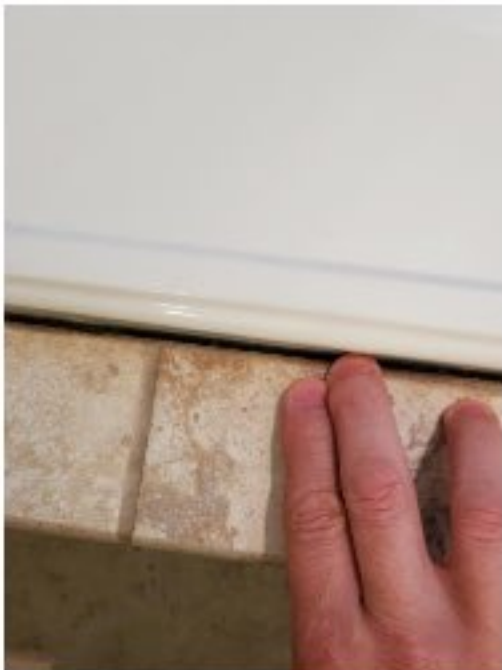
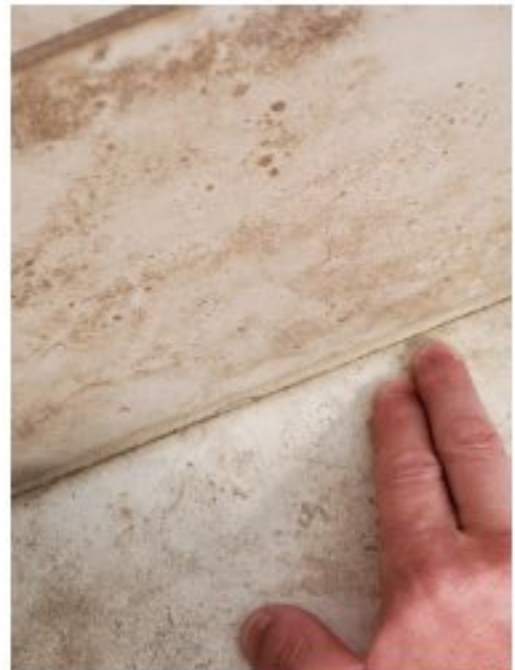
Tub has missing/cracked grout. This condition can allow water intrusion to subfloor and frame. Recommend sealing to prevent water damage.

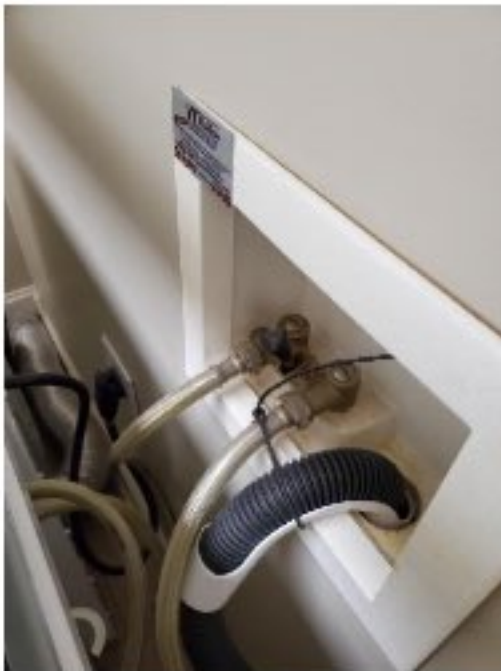
Appears Serviceable. However, the water supplies were not indicated as hot/cold. This could cause clothing to be washed at undesired temperatures. Recommend evaluation and labeling by a licensed plumber.

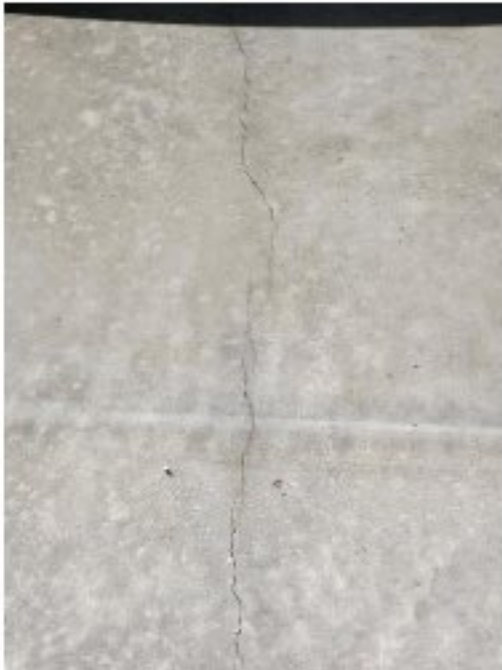
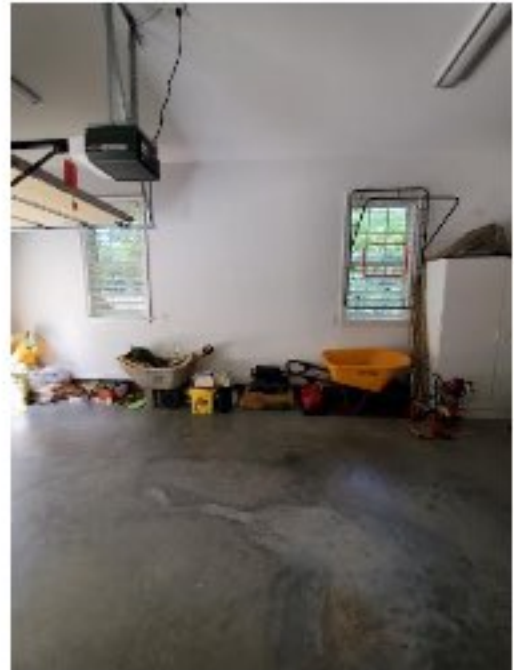
Garage floor had minor cracking. This is not uncommon. Recommend sealing to prevent water intrusion.

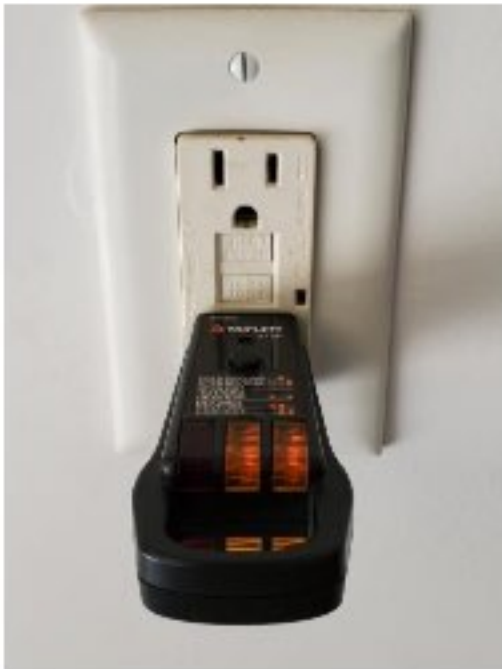
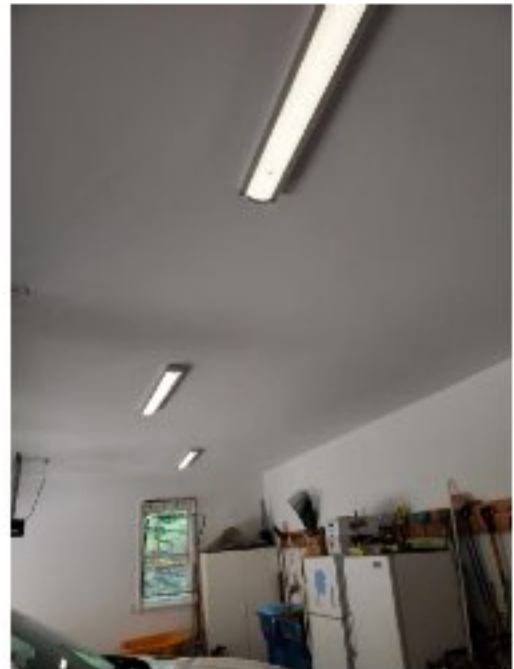
There is some concern of having refrigerator and freezer plugged into a GFCI protected circuit. These appliances cycle on and off repeatedly and often. This could cause the GFCI to trip and the appliances loose power. Recommend having refrigerator and freezer on non-GFCI circuits.

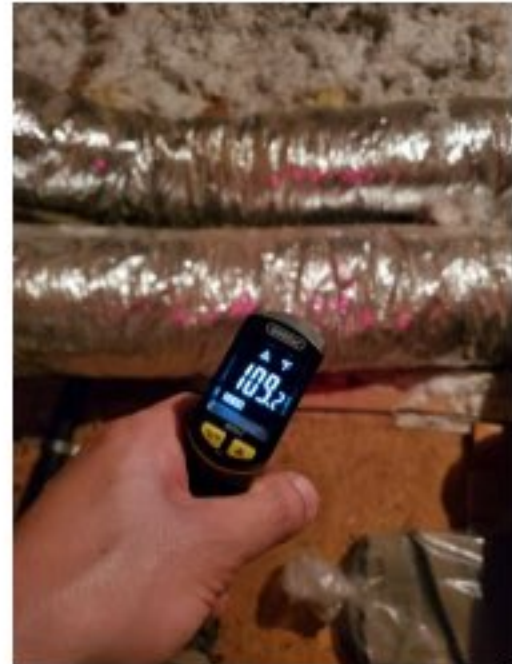
Minimal ventilation was provided to the attic area. This may not be sufficient to move air through the attic properly. Recommend installing additional vents or an exhaust fan. The floor temperature was approximately 105°F. The roof deck was approximately 120°F. The attic temperature should roughly be equivalent to the outside air temperature. The outside air temperature at the time of inspection was approximately 82°F.

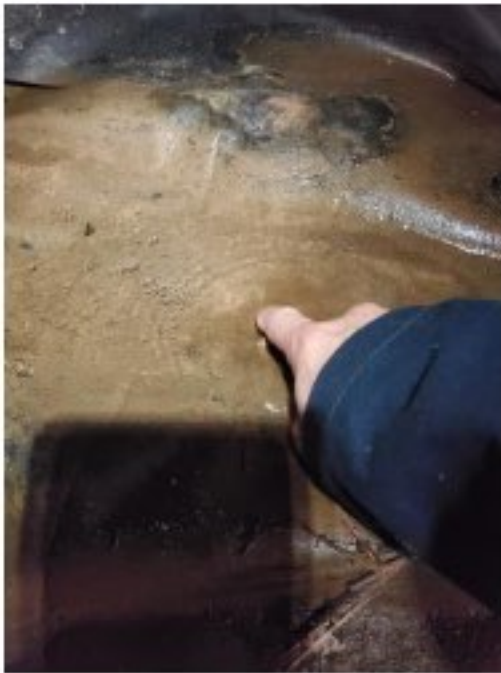
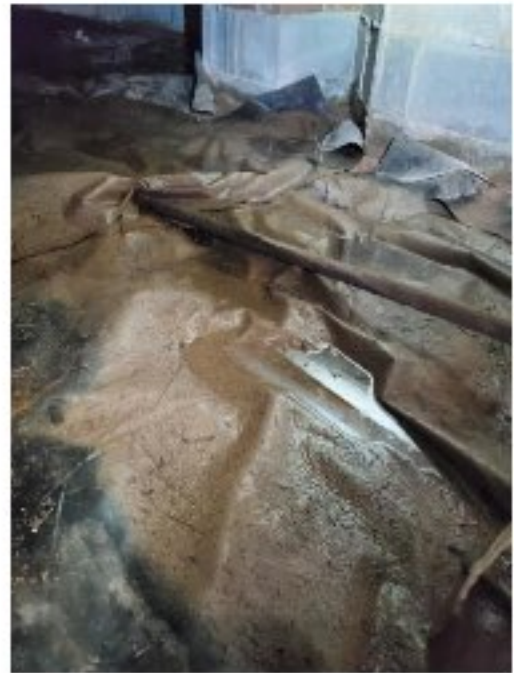
Excessive amounts of moisture were observed in the crawl space area. Additional ventilation and / or a vapor barrier should be considered. The conditions observed are conducive to wood rot, mold, rust and corrosion to pipes and wires. Recommend further evaluation by a waterproofing contractor. A mold inspection or testing was not performed as part of this general home inspection.

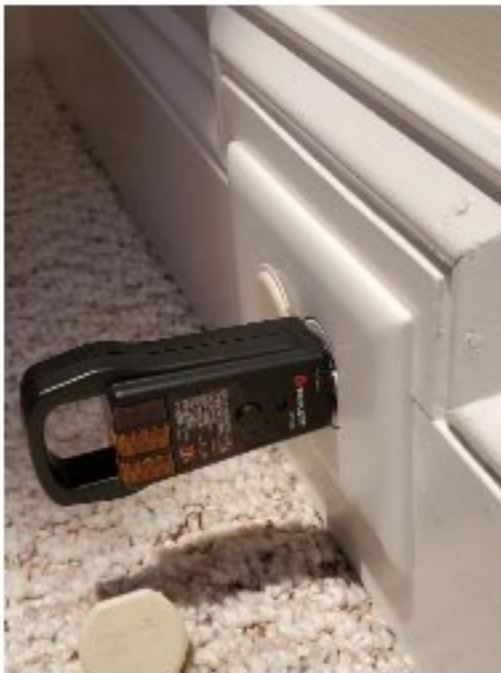
Receptacles inoperable. Recommend evaluation and repair by a licensed electrician.
