Inspection Report

Triad's Best Home Inspection

Approximate Year Built	2005
Approximate Square Footage	3,378
Number of Bedroom	4
Number of Bath	3.1
Direction House Faces	SW

Inspection Date	4May2021
Inspection Time	8:00am
Weather Conditions	Recently Rained.
Outside Temperature	66°F
Price for Inspection

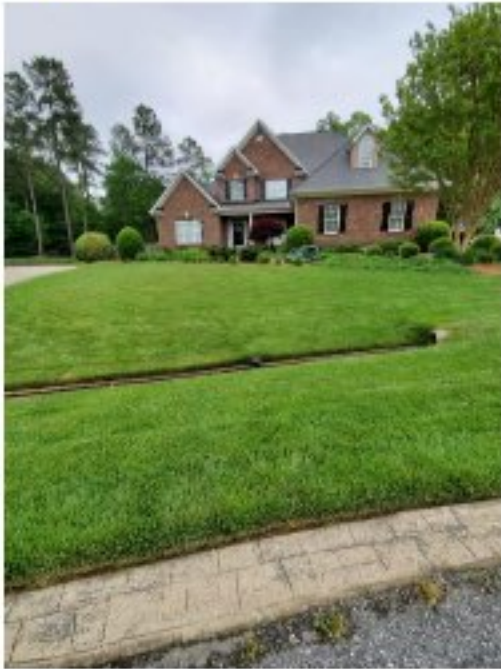
1.1) Grading Conditions

Grading of the soil near the foundation appears to be in serviceable condition.

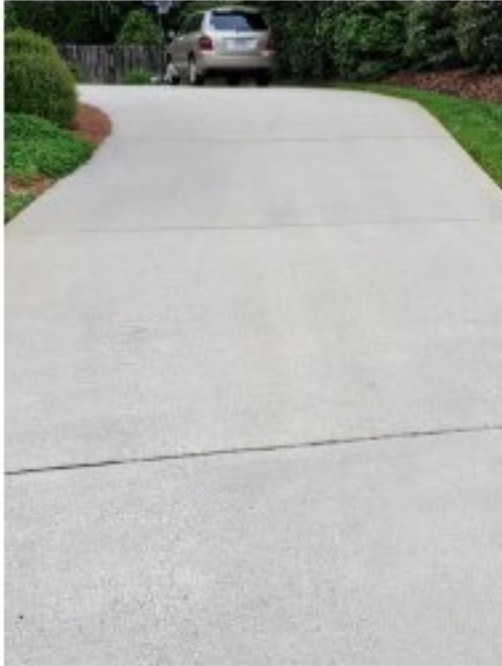
1.2) Driveway Conditions

Common cracks were observed in the driveway. Recommend sealing all cracks to prevent water intrusion and further damage.

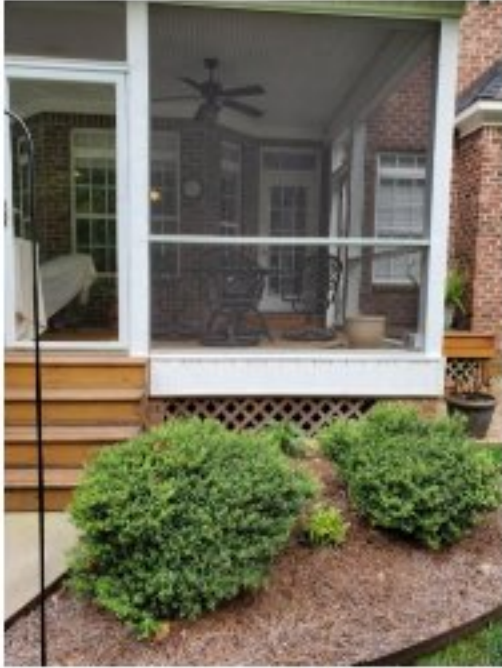
2.2) Back Entrance Conditions

There was no or limited access under the deck. The inspector was unable to fully inspect deck framing.

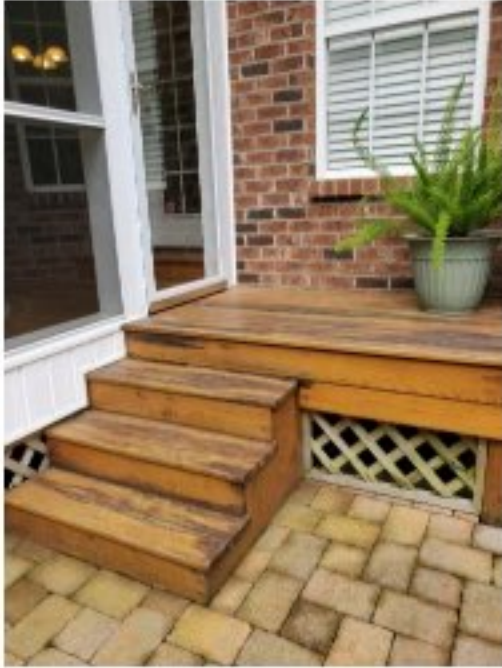
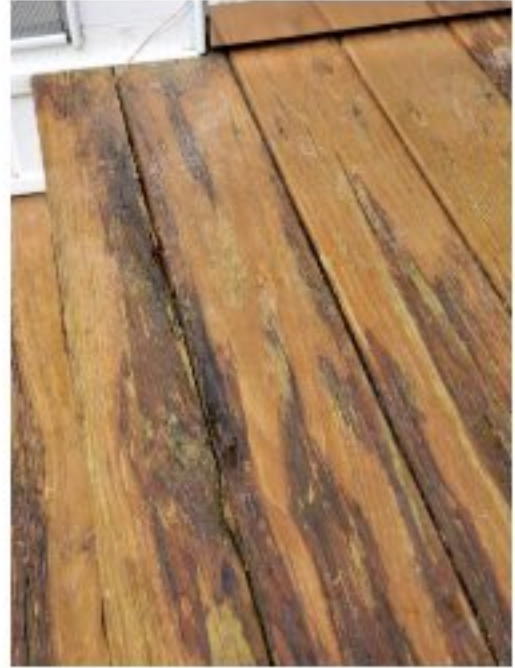
Some deterioration in deck boards noted at back porch entry area. The boards seemed solid and serviceable at the time of inspection. Recommend monitoring for further deterioration.

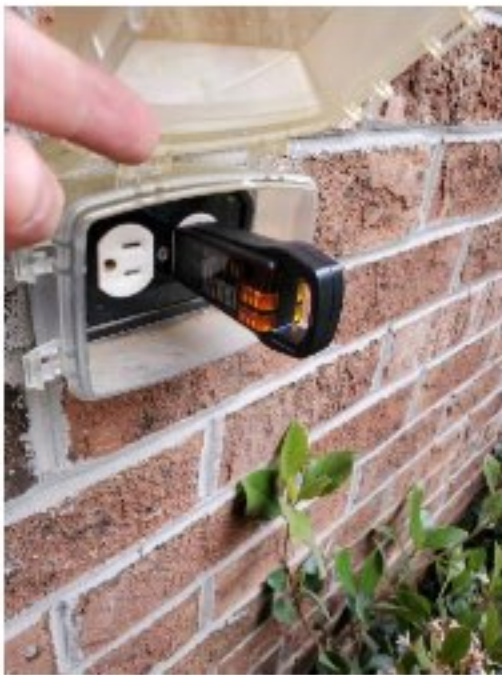
2.8) Front porch receptacle

Appears Serviceable. GFCI performed as intended at time of inspection.

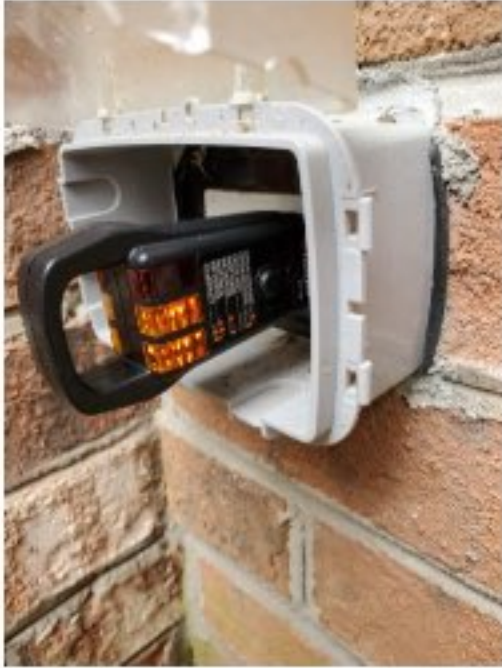
2.9) Back patio receptacle

Appears Serviceable. GFCI operated as intended at the time of inspection.

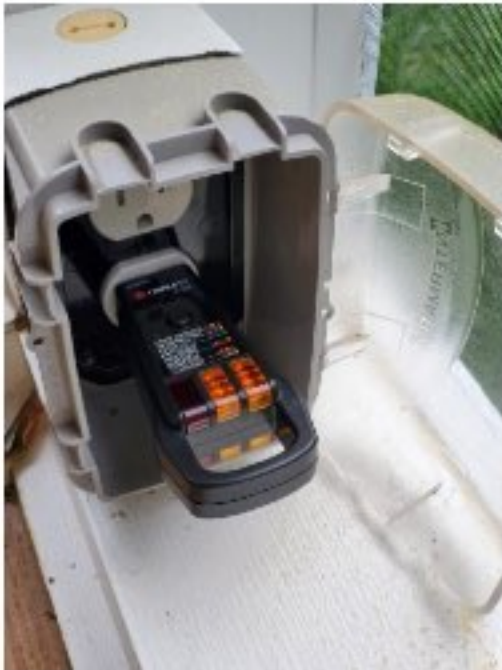
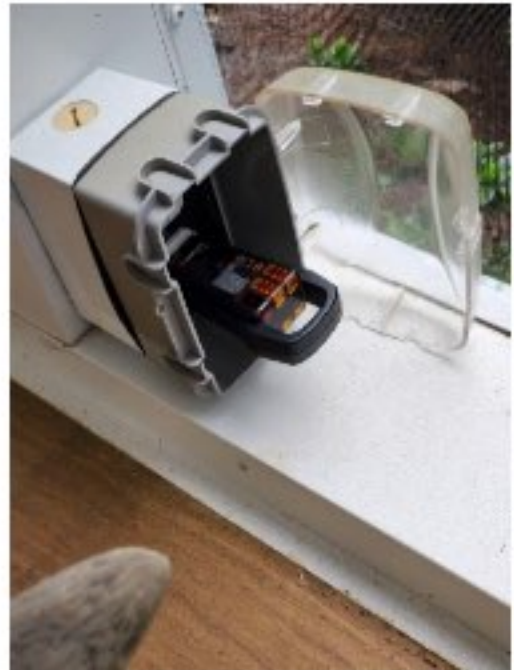
2.10) Screened porch receptacle

Appears Serviceable. GFCI operated as intended at the time of inspection.

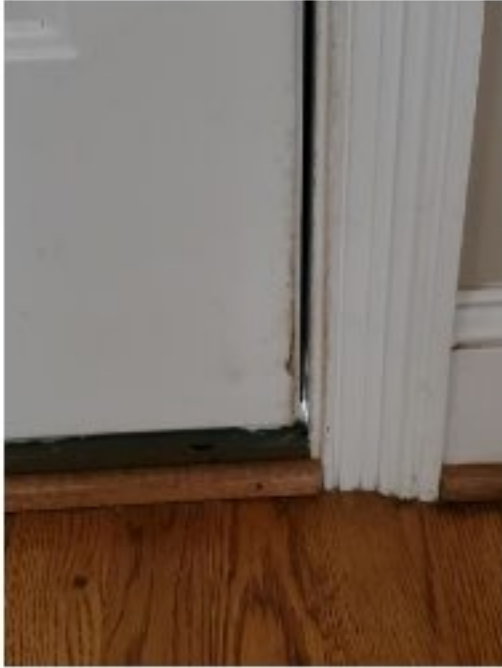
Light showed at bottom of closed door. This is an energy loss concern. Recommend weather stripping to be replaced by a qualified technician/door installer.

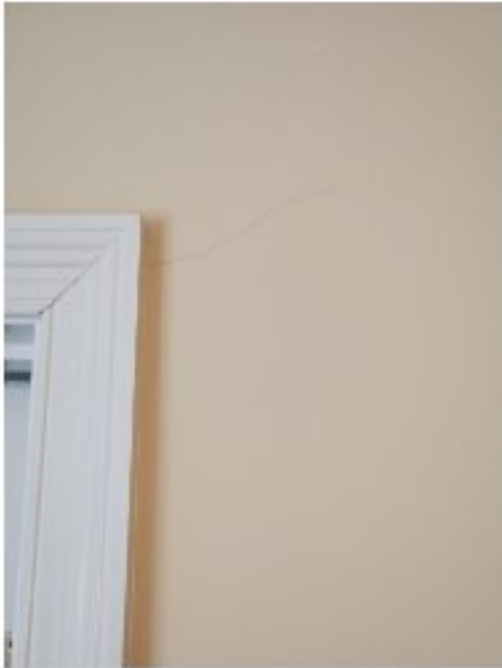
8.3) Walls, Floor, Ceiling

Crack over upper right corner of adjoining bathroom. Recommend monitoring for any increase in size.

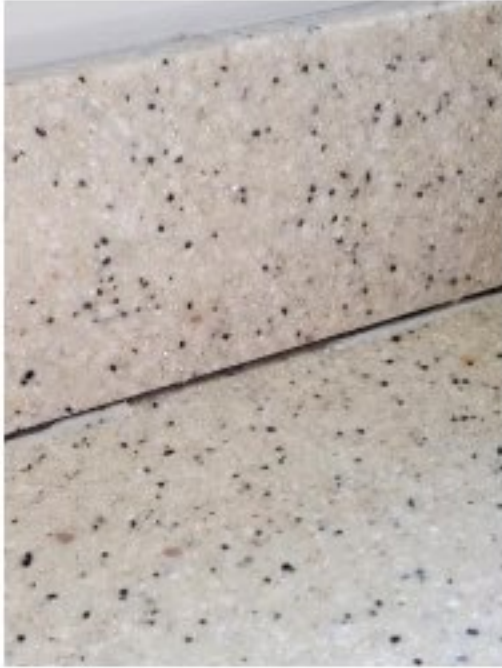
9.5) Counters, Cabinetry

Some sealant missing in areas. This can allow water intrusion into the walls and cabinetry. Recommend resealing by a qualified professional.

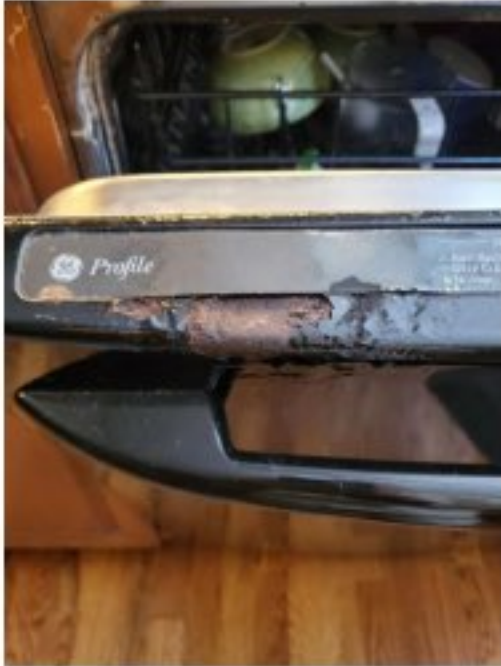
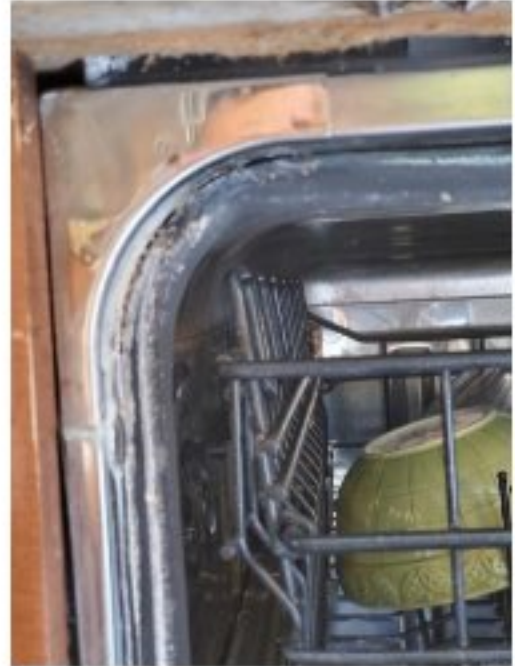
9.9) Dishwasher

Dishwasher showed signs of rust. Possibly caused by a bad seal. This condition can cause damage to the counter over time. Recommend repair of the seal or replacement of dishwasher by a qualified technician.

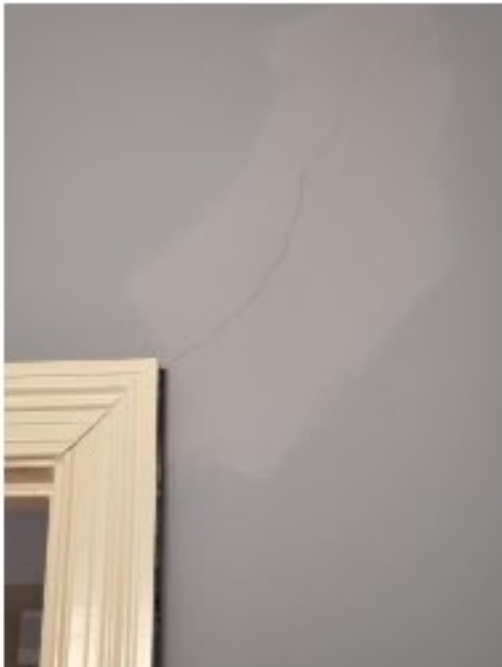
Crack at upper right side of door. Not uncommon, may indicate pier or foundation settlement. Recommend monitoring for any further cracking.

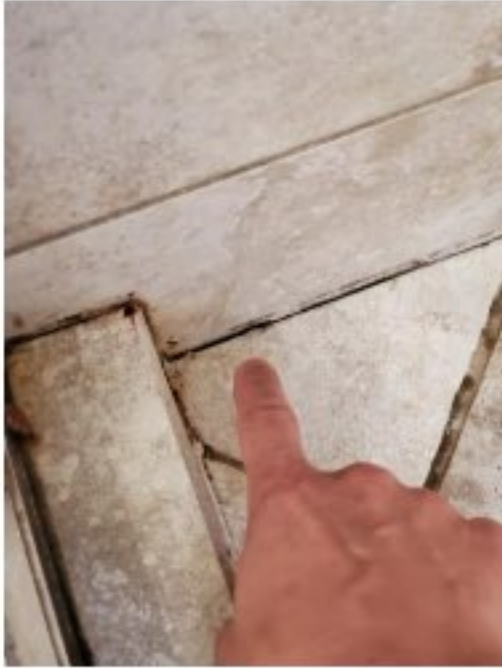
10.24) Tub

Tub has missing/cracked grout. This condition can allow water intrusion to subfloor and frame. Recommend sealing to prevent water damage.

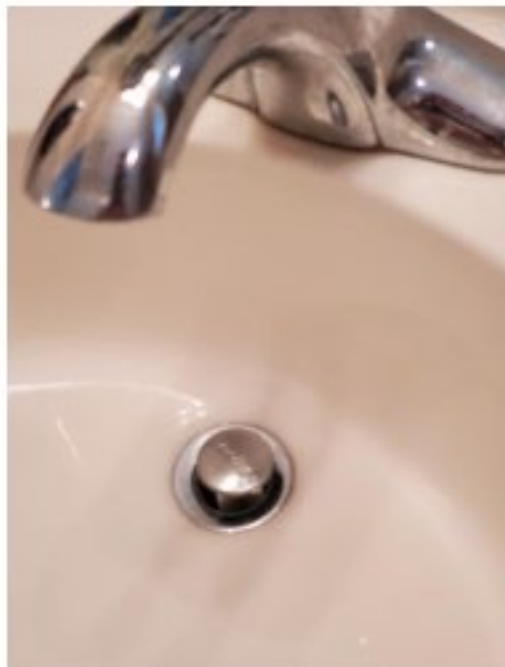
10.32) Fixtures

Sink stopper inoperable at time of inspection.

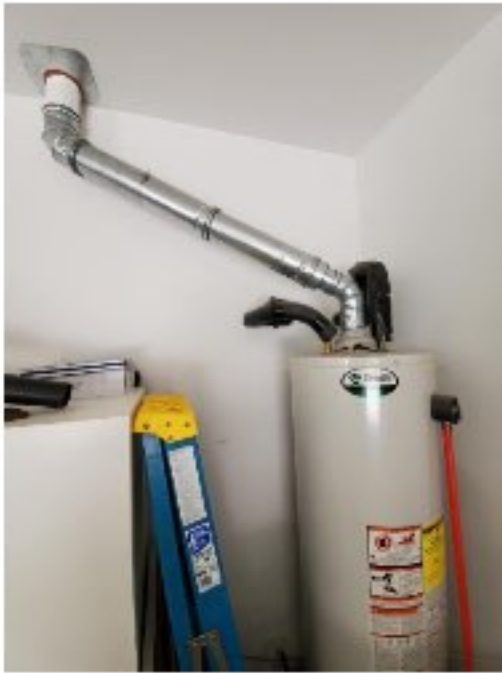
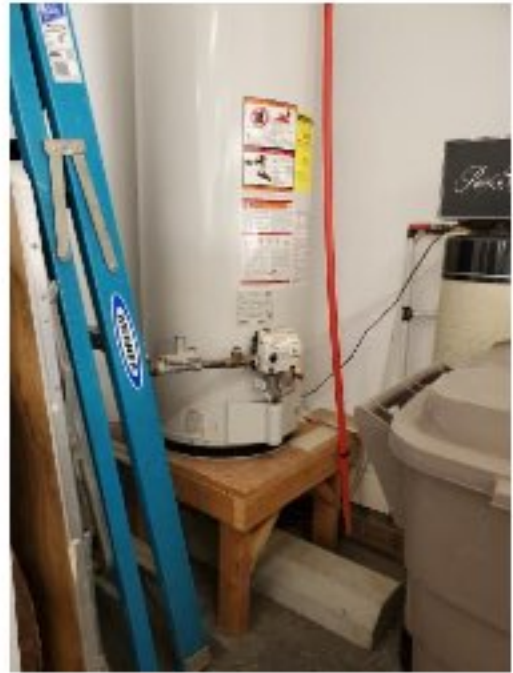
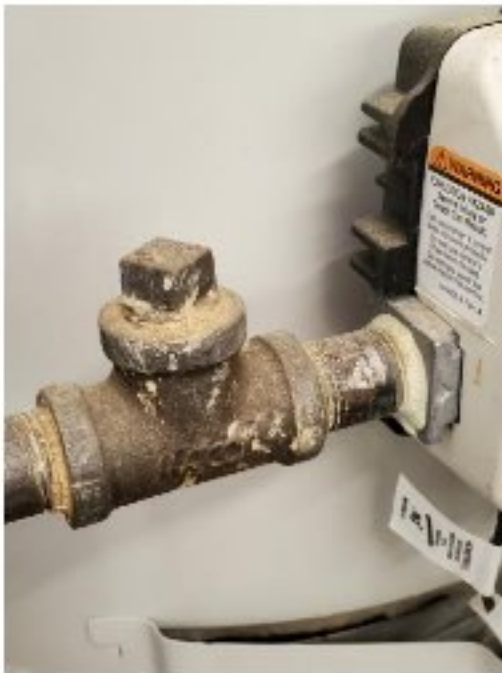
12.4) Water Heater Conditions

The water heater was operable at the time of inspection. This does not however guarantee future performance, operation, or condition.

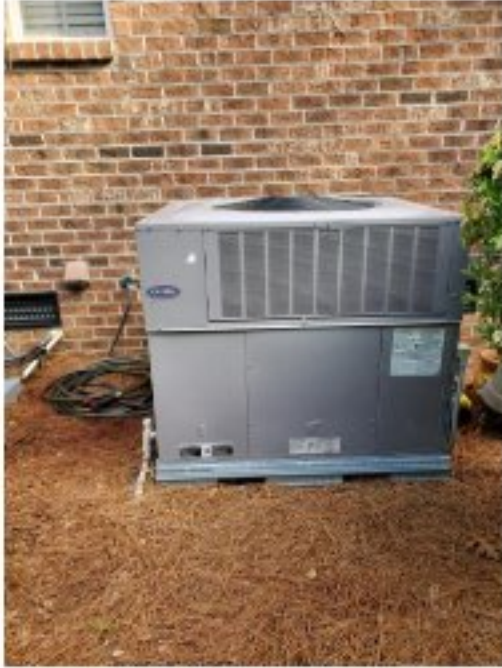
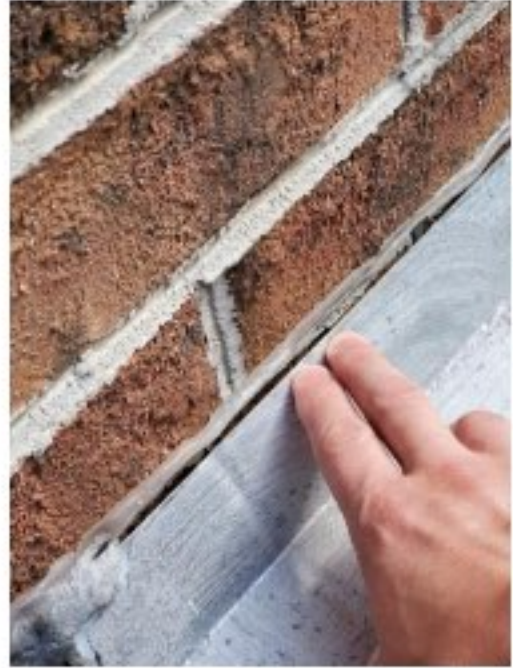
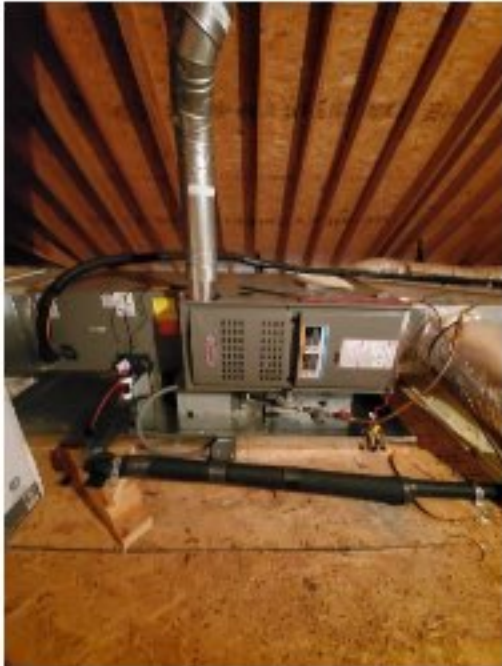
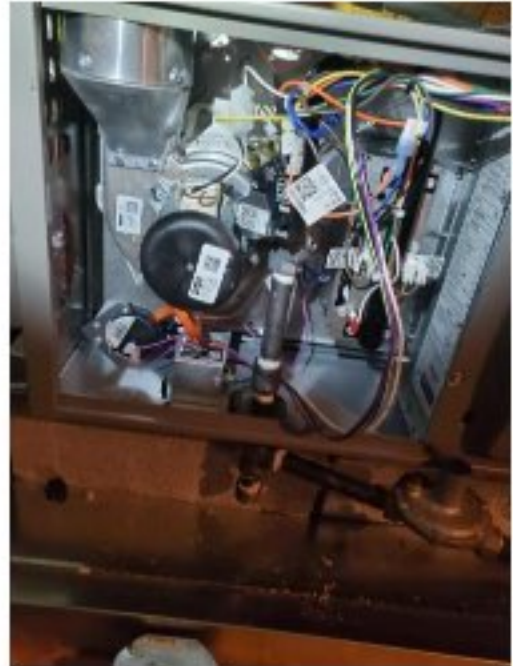
13.1) Unit Conditions

Duct sealant insufficient at wall entry. This allows water intrusion as well as energy loss. Recommend sealing by a qualified HVAC professional.

Attic unit heating system was operational at time of inspection. This is not an indication of future operation or condition.

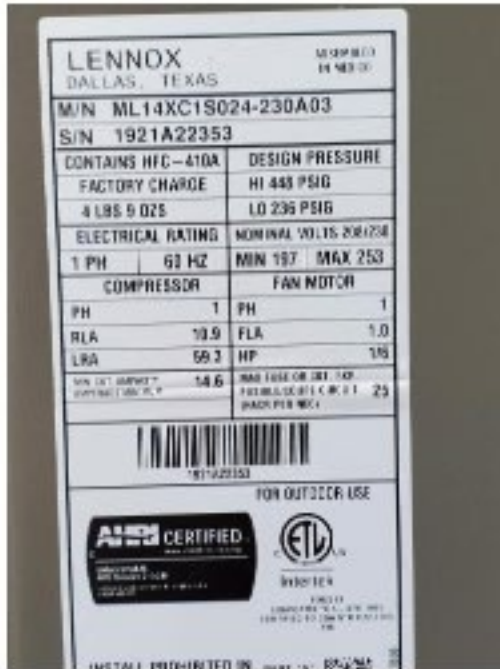
13.5) AC Unit Conditions

Appears Serviceable.

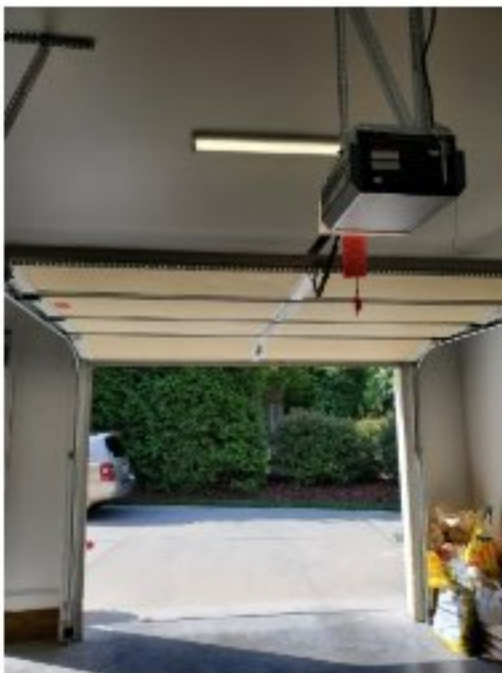
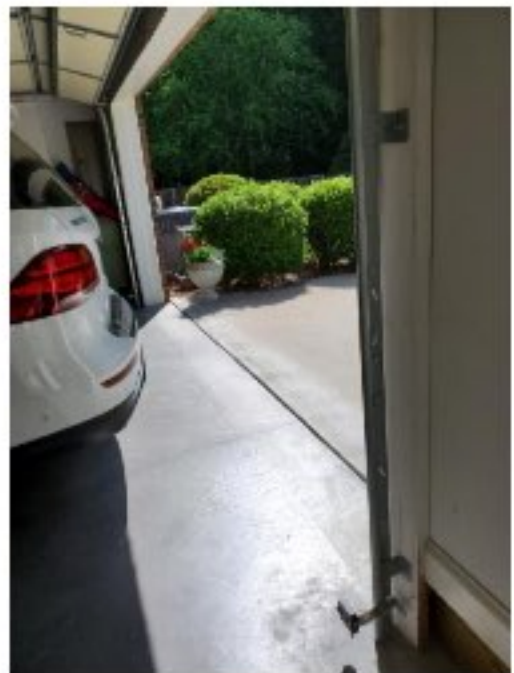
Doors operated as intended at the time of the inspection. Pressure stop and IR eye safety features operated properly at the time of the inspection.

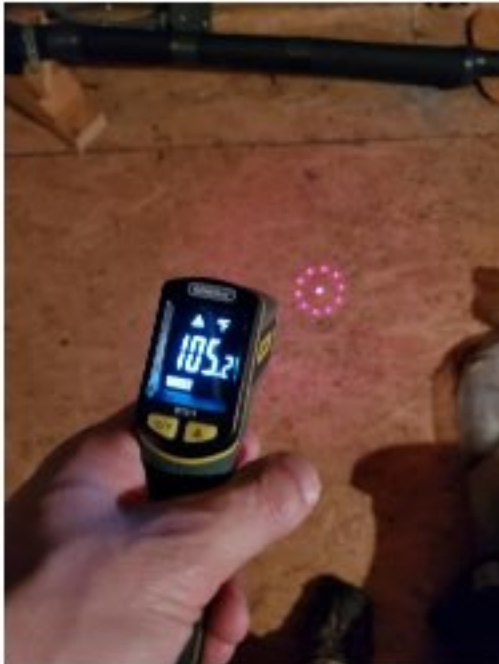
16.2) Attic Ventilation Conditions

Minimal ventilation was provided to the attic area. This may not be sufficient to move air through the attic properly. Recommend installing additional vents or an exhaust fan. The floor temperature was approximately 105°F. The roof deck was approximately 120°F. The attic temperature should roughly be equivalent to the outside air temperature. The outside air temperature at the time of inspection was approximately 82°F.

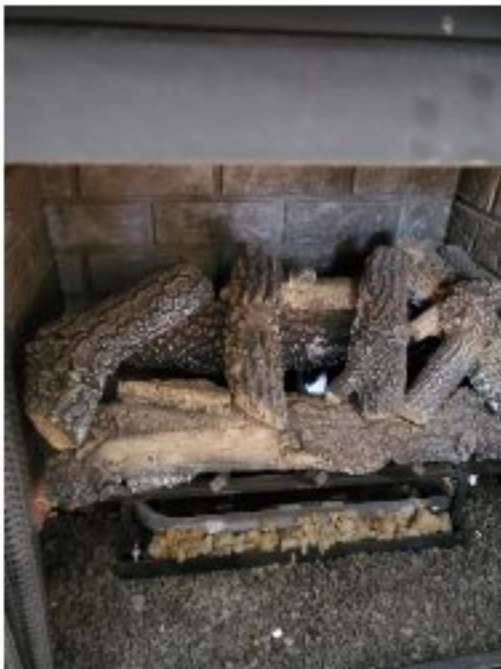
17.2) Fireplace Conditions

The fireplace is gas fired and was operable at the time of inspection. No flue was observed at this unit. Depending on the type and manufacturer, some of these units burn cleanly and do not require a flue. Client is advised to obtain information from the manufacturer regarding use, maintenance, and carbon monoxide risks, if any.

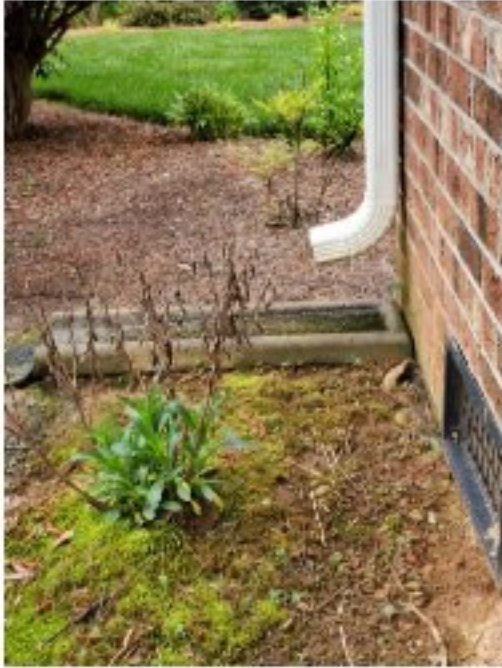
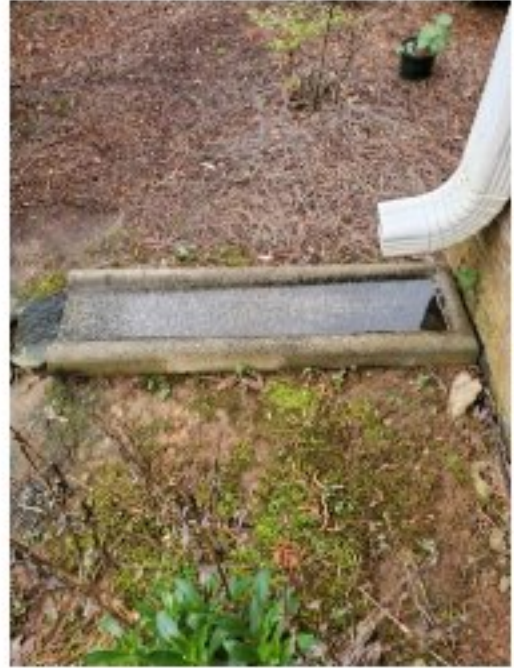
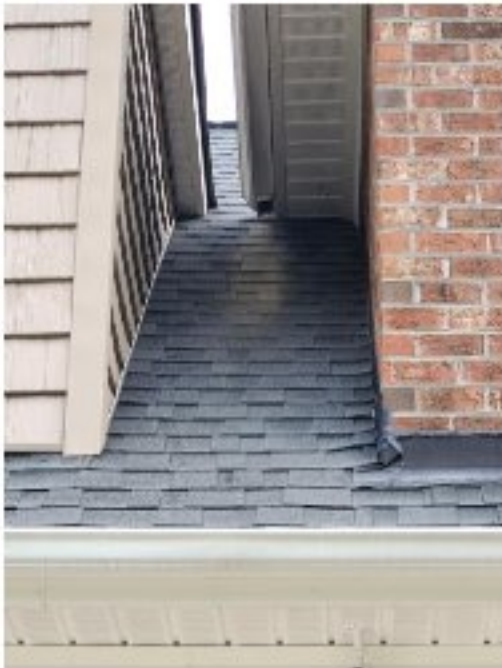
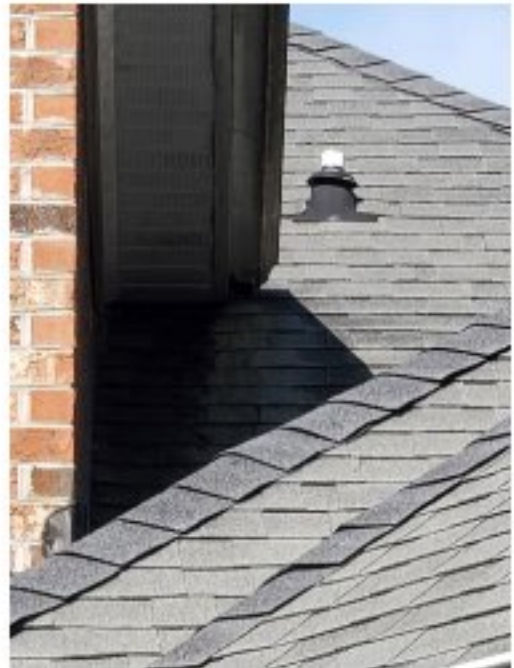
18.3) Gutter & Downspout Conditions

Downspout at rear left corner terminates high from the splash block. Splash block sloped toward the house. The high termination can allow water to miss the splash block, causing erosion and possibly water pooling near the foundation. The splash block sloped to the home is directing water to the foundation.

Down spout missing from upper gutter to lower gutter. Best practice is to control water all the way to the ground. No down spout at this area can cause premature shingle deterioration and/or water intrusion at wall flashings. Recommend correction by a licensed gutter installer.

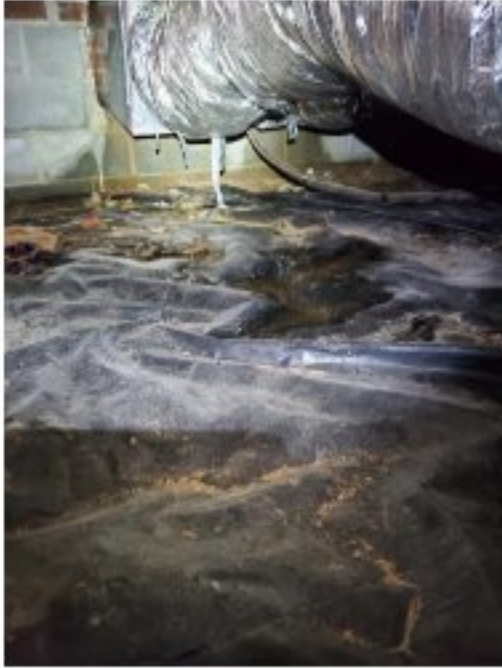
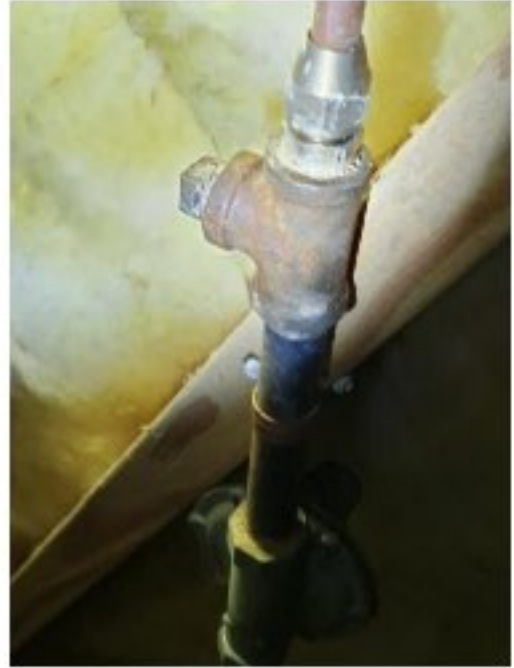
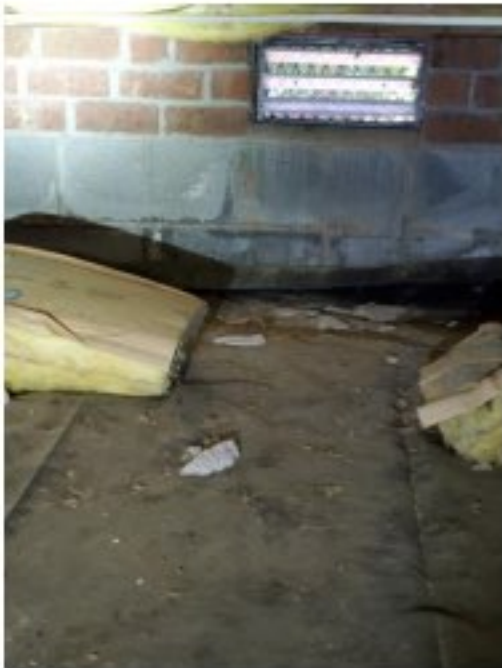
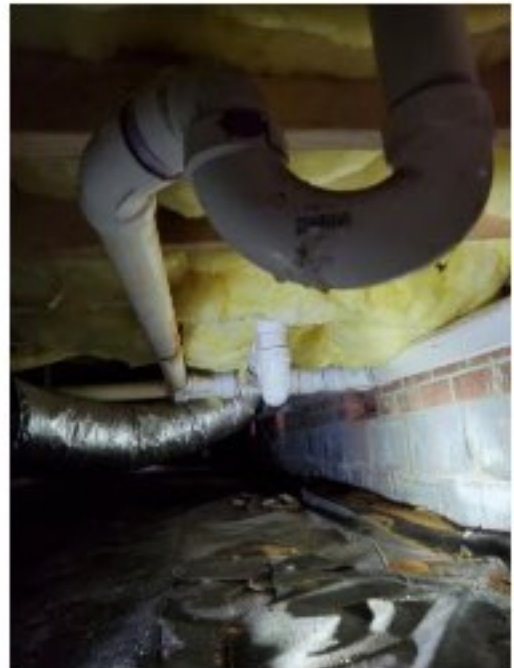
19.1) Foundation Conditions

Excessive amounts of moisture were observed in the crawl space area. Additional ventilation and / or a vapor barrier should be considered. The conditions observed are conducive to wood rot, mold, rust and corrosion to pipes and wires. Recommend further evaluation by a waterproofing contractor. A mold inspection or testing was not performed as part of this general home inspection.
